Scientific Report

Ultrasonographic diagnosis of the retained semen straw in the uterus of a repeat breeder cow

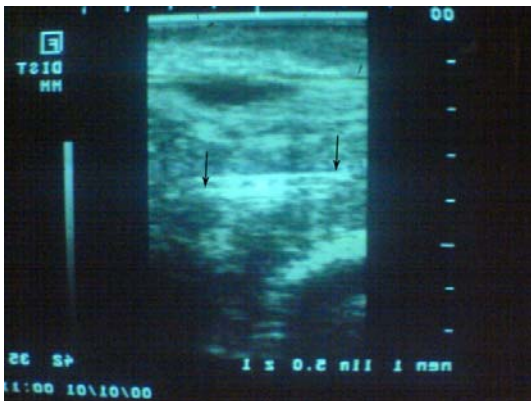
Fig. 1: Ultrasonographic view of the retained semen straw in the uterus of the cow. Note the two white lines in parallel in the uterus (arrows). Image was obtained using a 5-MHz linear probe

Teaching Hospital of the School of Veterinary Medicine, Shiraz University. According to the owner's statements, no abnormal clinical signs or uterine discharge had been observed subsequent to AI. The cow had shown signs of oestrus on a cyclic and regular basis. On rectal examination, the uterine wall was slightly thick and edematous with no palpable object or pathologic fluid inside the uterus. Transrectal ultrasonography revealed an edematous uterus with a semen straw-like structure in the left uterine horn (Figs. 1 and 2). The full length of the semen straw was visible on the monitor by moving the transducer across the left uterine horn. The walls of the straw were seen in parallel as white. In order to remove the straw through left-flank laparotomy, the surgical site was prepared for aseptic surgery in a routine manner. The surgical procedure was performed with the animal standing and the anesthesia was provided by an inverted L

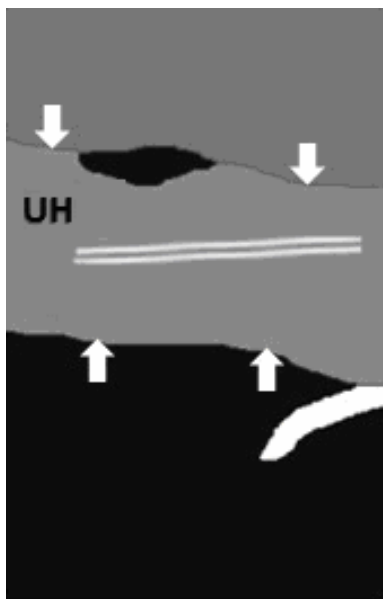
Fig. 2: Schematic presentation of the longitudinal section through the uterine horn (UH; shown by arrow head) of the cow. The semen straw is shown in the uterine lumen

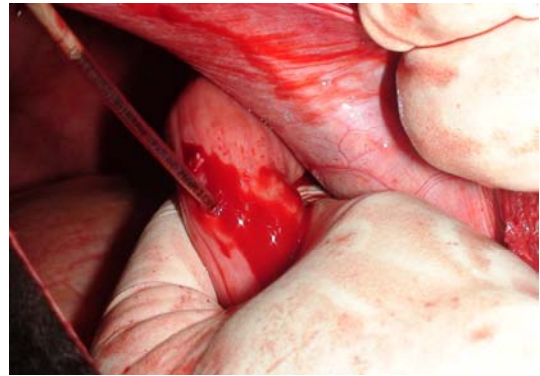
Fig. 3: An incision was made over the tip of the palpable straw and it was exited by a thumb forceps

block using 2% lidocaine hydrochloride. Following entrance into the peritoneal cavity, the left uterine horn was manipulated for the portion containing the straw. A 2-cm incision was made over the tip of the palpable straw and it was exited by thumb forceps (Figs. 3 and 4). The straw was a 0.5 French sized. The incision was closed by Vicryl No. 2 in double inverted suture pattern. The uterus was replaced in position and the laparotomy incision was closed routinely. The follow-up study for two months revealed no complications. No

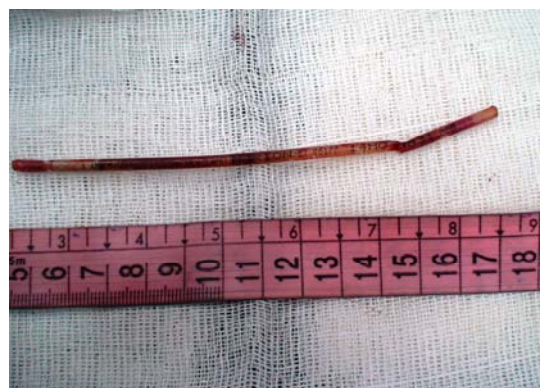
Fig. 4: Removed straw from the uterus
